MP 3-75

Features of Various Offshore Structures

MISCELLANEOUS PAPER NO. 3-75

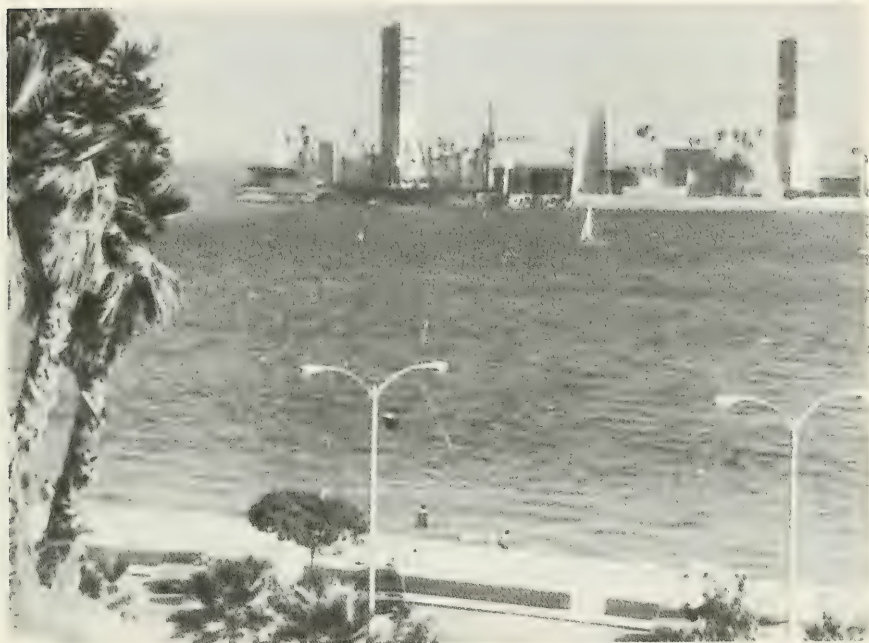
Figure 6. View of Island White from Long Beach waterfront (August 1973).

(b) Type. Armor rock perimeter with dredged sand-filled core (Fig 6).

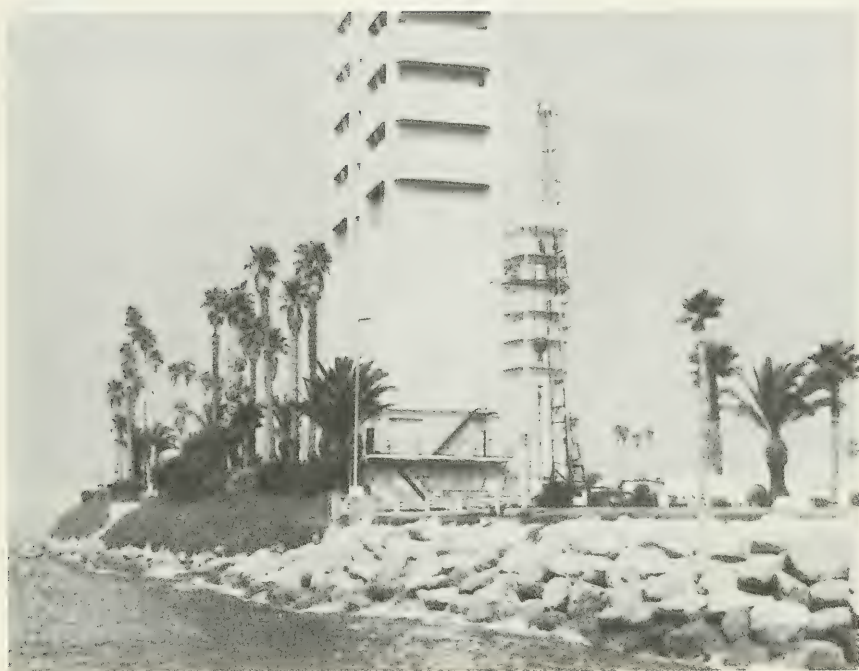
Figure 10. Typical view of island shoreline showing landscaping along top of armor protection and buildup of encircling berm to conceal most of the operational activity from the mainland. Note the camouflage of main drill derricks in decorative towers (August 1973).

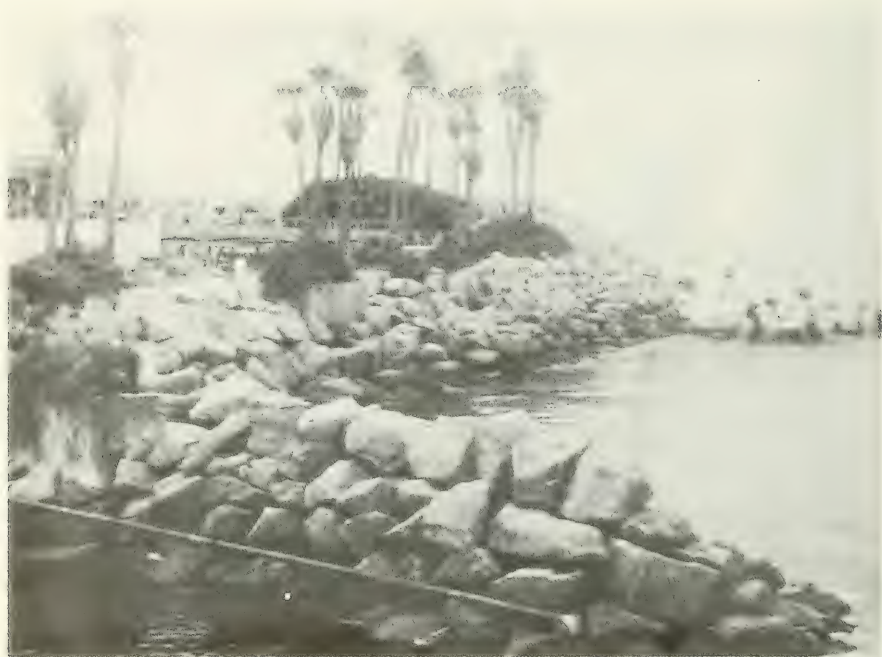
Figure 15. View of north side of island showing unusual configuration and good condition of armor rock (August 1973).

(b) Unusual Features. The unusual configuration developed from the attempt to obtain best wave protection (Fig. 15). To obtain the most economical but adequate design, extensive studies were conducted to determine most suitable configuration and orientation. The peculiar, partially protected aspect of the site seemed only to introduce additional factors for consideration in these studies and led to the concept of the more protective seaward face to resist the larger waves.

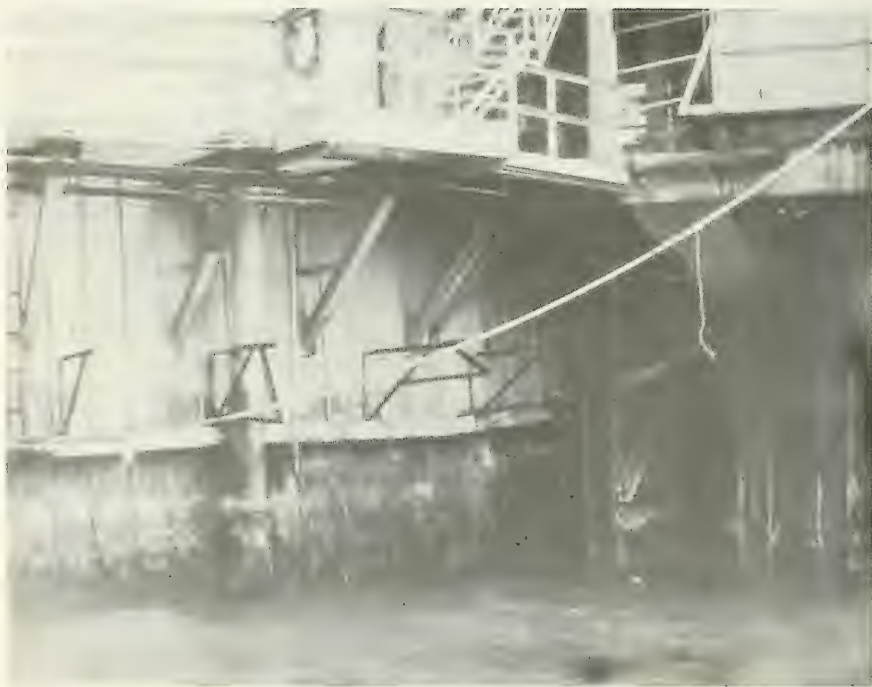
Figure 19. View of steel sheet piling. Note painted area above high tide line, free of marine growth.

(b) Biota. Marine growth on the underwater, unpainted areas attracts fish which in turn attract sport fishermen (Fig. 19).

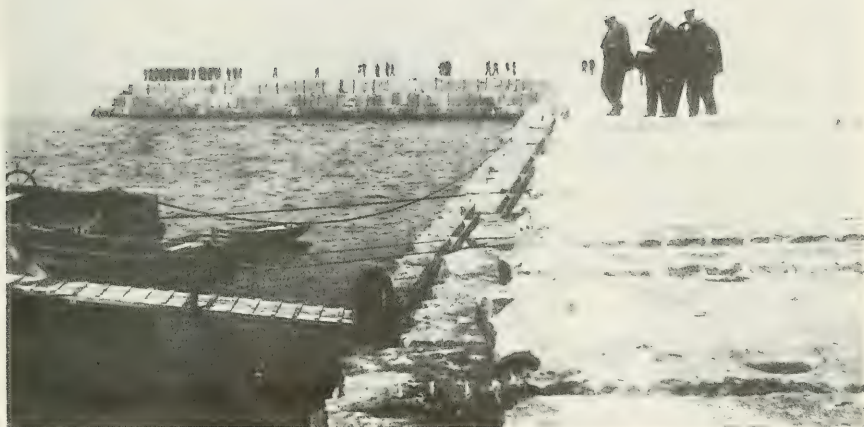
Figure 23. Looking north along the granite block superstructure of the breakwater (1916).

(b) Unusual Features. Workmanship and craftsmanship exhibited in breakwater superstructure of uniform-cut granite blocks laid flat and in horizontal courses (Fig. 23).

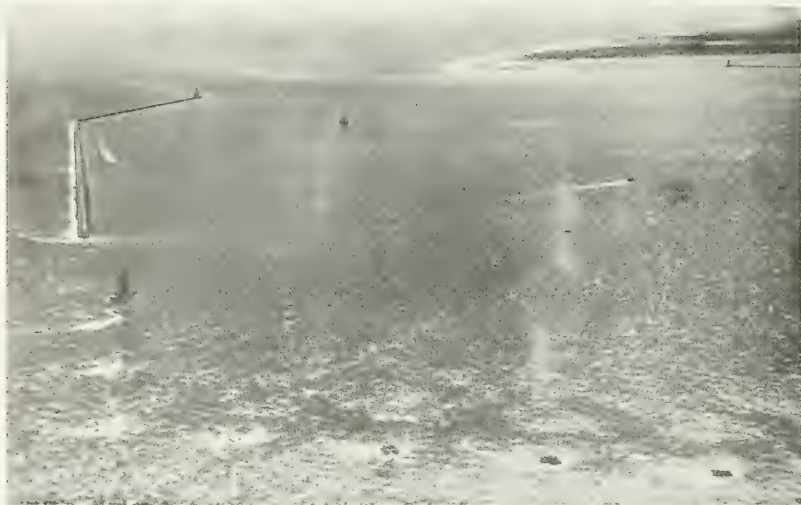
Figure 24. Aerial view southeastward toward Cape Henlopen. Ice piers in foreground and outer breakwater at left; old breakwater close inshore at right (U.S. Army Engineer District, Philadelphia—in press, 1974).

(b) Type. Rock mound (Fig. 24).

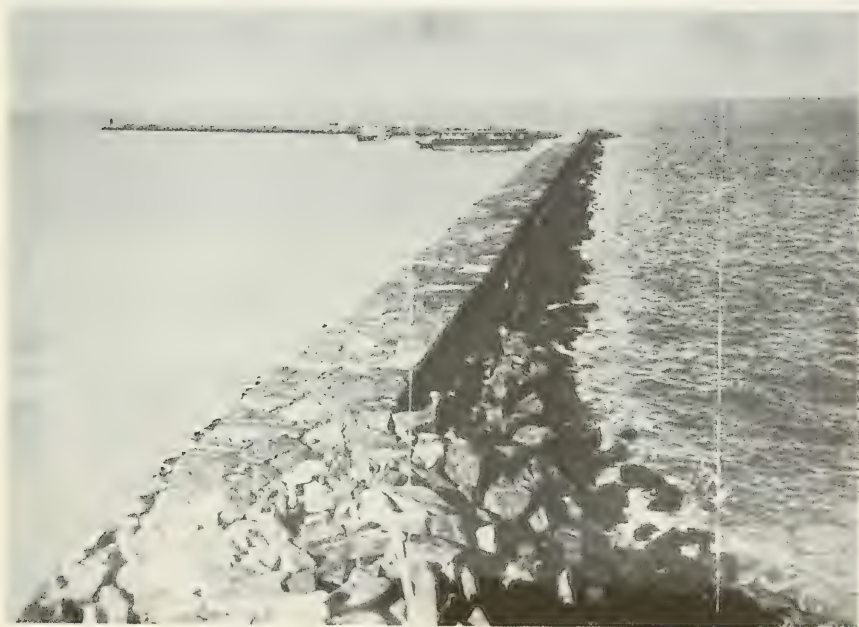
Figure 32. View northward along top of "Gap" construction with ice breaker in background (photo taken in 1890's). Note relatively calm water on harbor side (U.S. Army Engineer District, Philadelphia—in press, 1974).

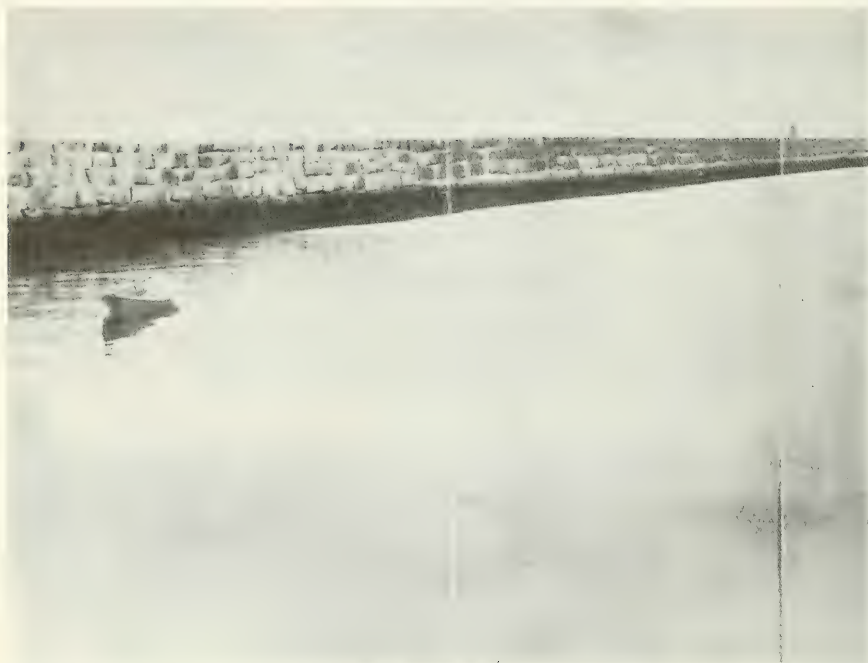
Figure 33. View southward along harbor side of “Gap” construction (photo taken in 1890’s)
(U.S. Army Engineer District, Philadelphia—in press, 1974).

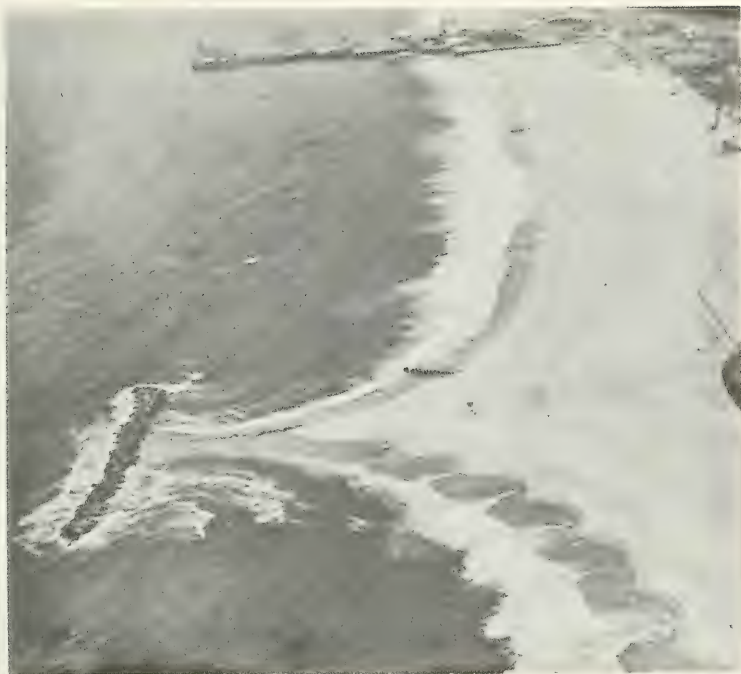
Figure 34. Aerial oblique photo of Venice Breakwater (Inman and Frautschy, 1965).

(b) Type. Rock mound (Fig. 34).

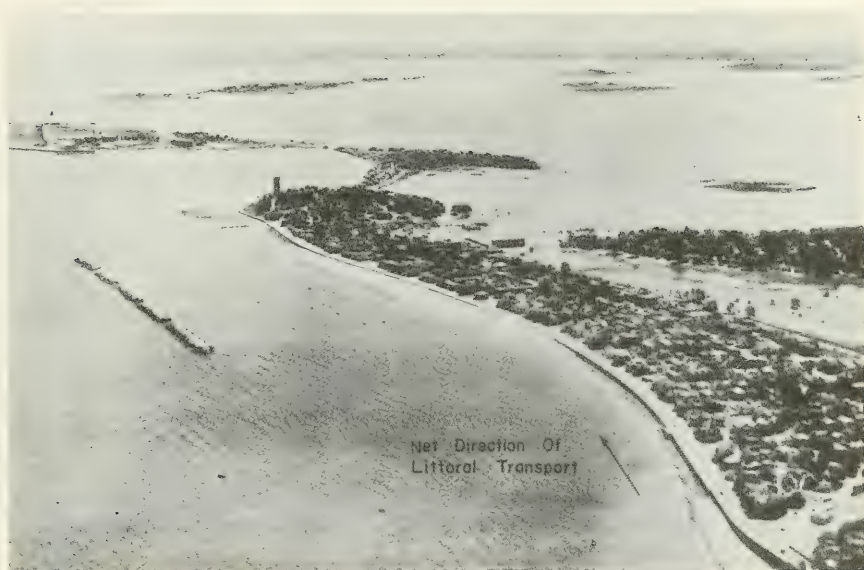
Figure 37. View of breakwater from northeast, (1949) (U.S. Army, Corps of Engineers, Coastal Engineering Research Center, 1966).

(b) Type. Rubble-mound breakwater (granite) (Fig. 37).

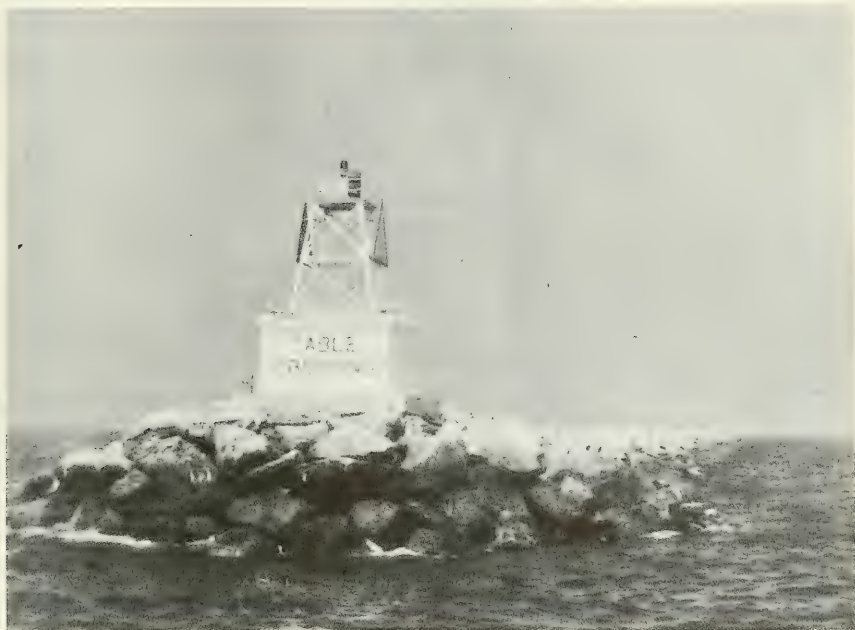
Figure 41. View of west end of middle breakwater (August 1973).

(2) Type. Sand and clay mound covered with rock blankets (Fig. 41).

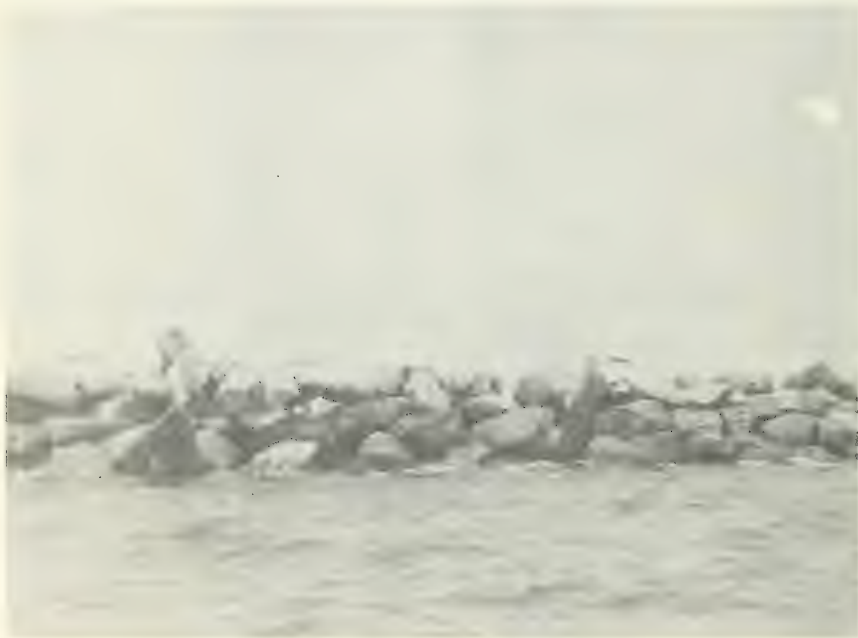
Figure 45. View on ocean side of middle breakwater showing displaced capstones (August 1973).

(1) Performance. No indication of failure, although a single capstone in various locations has been upended due to wave action. In 1968, at one point near the eastern end of the middle breakwater, a ship struck the breakwater from the ocean side, dislodging several stones (Fig. 45). Since no further damage was apparent, no repair has been undertaken. Settlement due to breakwater construction has been negligible.

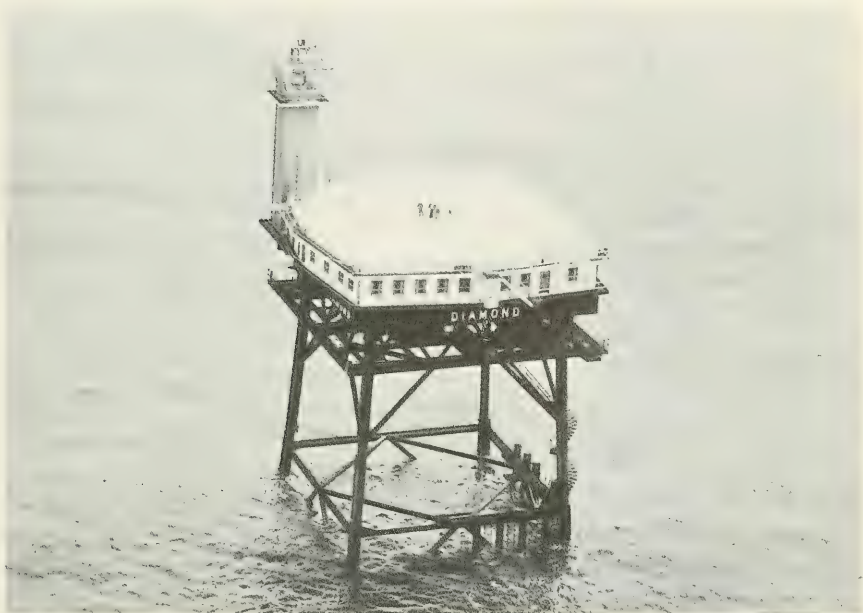
Figure 46. Aerial view of Diamond Shoals Light Station.

(2) Type. Pile-supported jacket-type structure (Fig. 46). Steel piles driven through a prefabricated steel-trussed template. Superstructure of prefabricated sections.

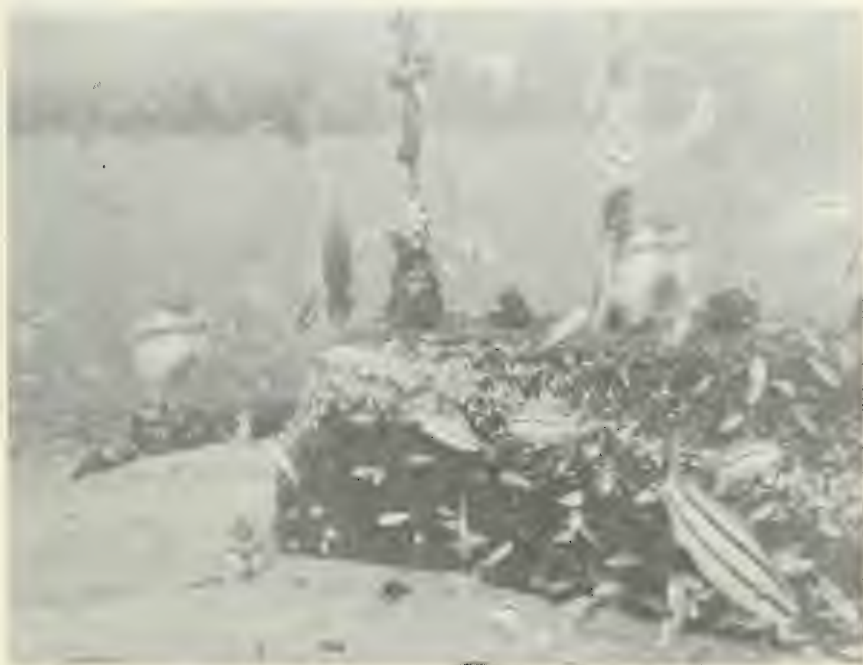
Figure 48. View showing marine life beneath tower.

(2) Biota. No recorded data. Several underwater inspections have reported heavy marine growth on the structure and that fish are attracted to the structure (Fig. 48). Occupants report birds are also attracted.

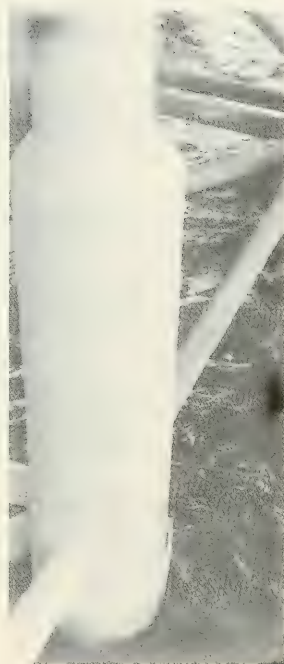
Figure 54. View of oil storage platform showing concrete jacket, piles, and deck (upper photo); bottom views show the concrete jackets and piles, with guniting steel pipe bracing.

One support suffered a head-on collision by a work boat which broke through both jacket and pile wall, leaving a hole 5- by 1.5-feet wide. This was repaired by enlarging the break to sound concrete, wrapping a steel sleeve around the section, and grouting the broken area and the interior.

(2) Maintenance. Regularly scheduled inspections are made of the structural areas of the platforms, including a divers' inspection of the underwater parts. The only deterioration noted has been the spalling off of the Gunitite coating on the steel collars and cross braces (Fig. 54). All piling and bracing between water surface and platform are regularly sandblasted and painted. This has been satisfactory in preventing corrosion of the bare steel, but the owner feels that using galvanized steel would be advisable in the future.

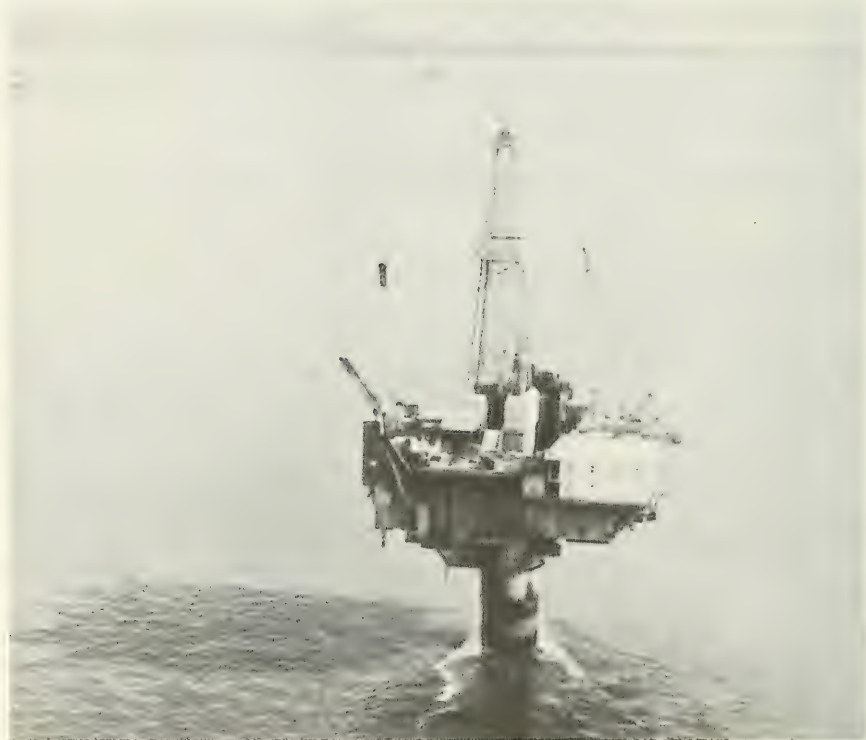
Figure 55. Aerial view of "monopod" platform.

(b) Type. Steel center post with flooded pontoon base supporting operations platform (Fig. 55).
